# New York State Department of Transportation

## Yellow Flag NB2258W016

**BIN: 1065318**

Location: Span 50, Stringer S1 at Pier 49 above 3rd Avenue EB Service Road between 61st to 62nd Street.

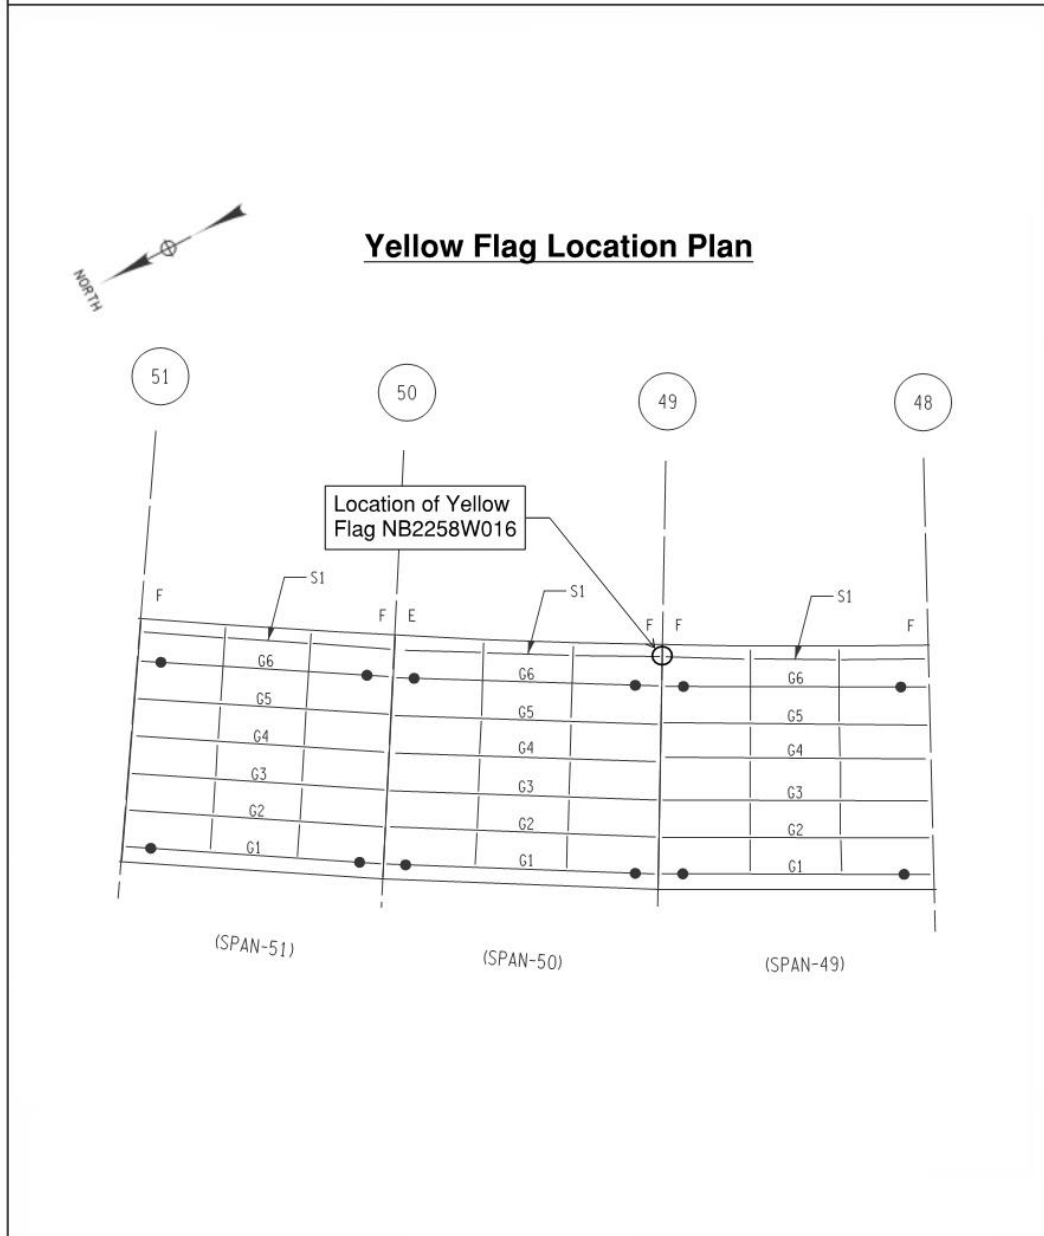
**Attachment Description: Yellow Flag Location Plan**

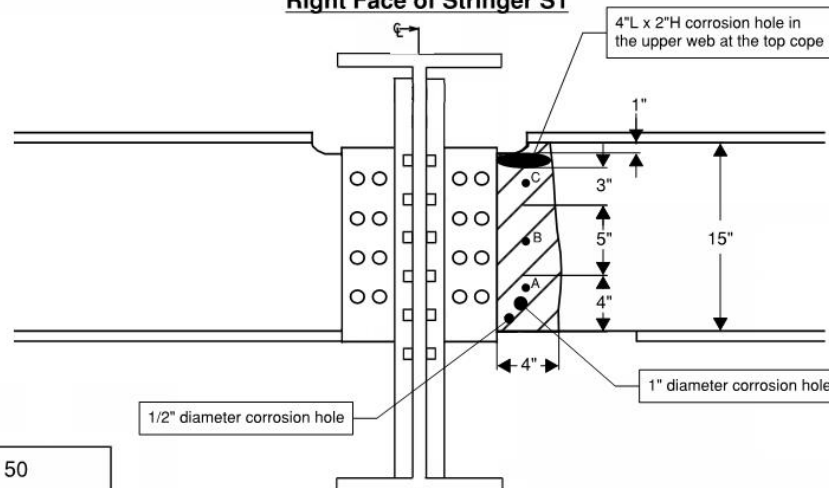
Photo Number: 2

Point	D-Meter Readings (in)	Calculated Section Loss
A	0.13	68%
B	0.29	28%
C	0.2	50%

**Section loss Calculations:**

Original web thickness = 0.40" (measured in field)

Shear web area:

$$(0" \times 1/2") + (0" \times 1") + (0.13" \times (4" - 1.5")) + (0.29" \times 5") + (0.20" \times 3") + (0" \times 2") = 2.375 \text{ in}^2$$

Overall shear web area section loss:

$$[(14" \times 0.40") - 2.375 \text{ in}^2] / (14" \times 0.40") \times 100 = 58\% \text{ section loss}$$

- The left side bottom flange of the stringer exhibits 25% section loss at the edge of the flange for 18"L x 2"W.
- The length of this portion of Stringer S1 between Pier 50 and TB1 is approximately 16ft.
- The distance from the edge of the roadway to the right fascia steel plate is approximately 26".
- The distance from the right face of the Stringer S1 web to the right fascia steel plate is approximately 25".

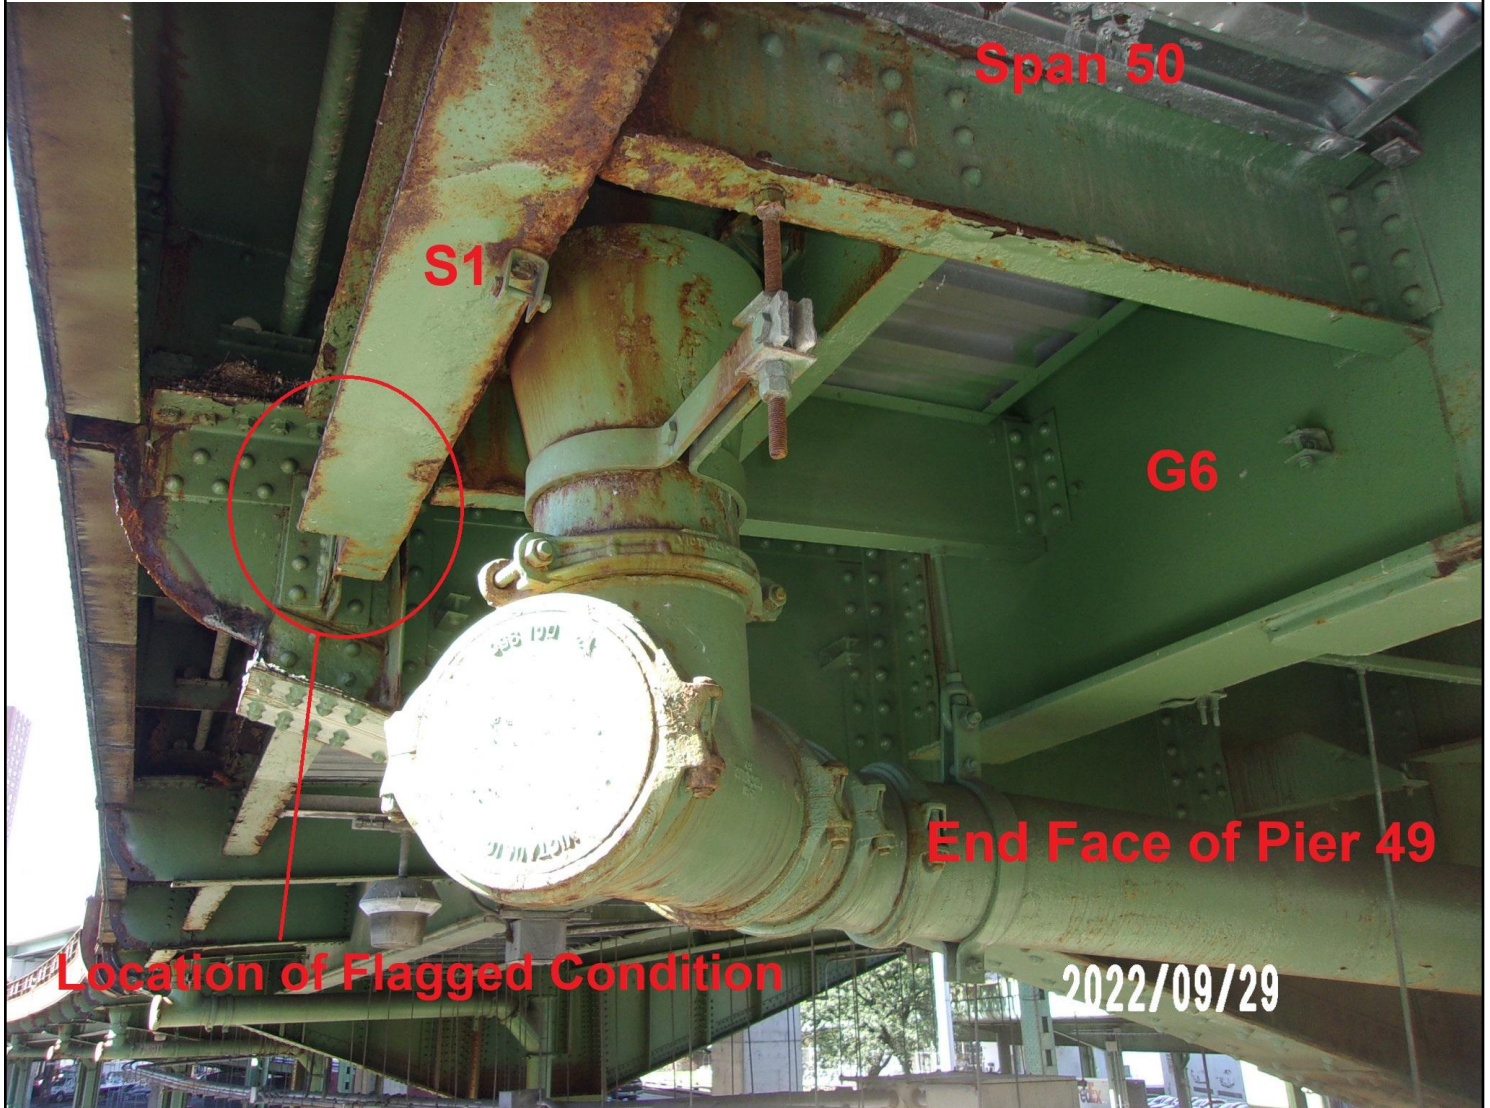
Photo Number: 3

**Attachment Description:** General view of the flagged condition at Stringer S1 in Span 50 at Pier 49. Looking Begin.

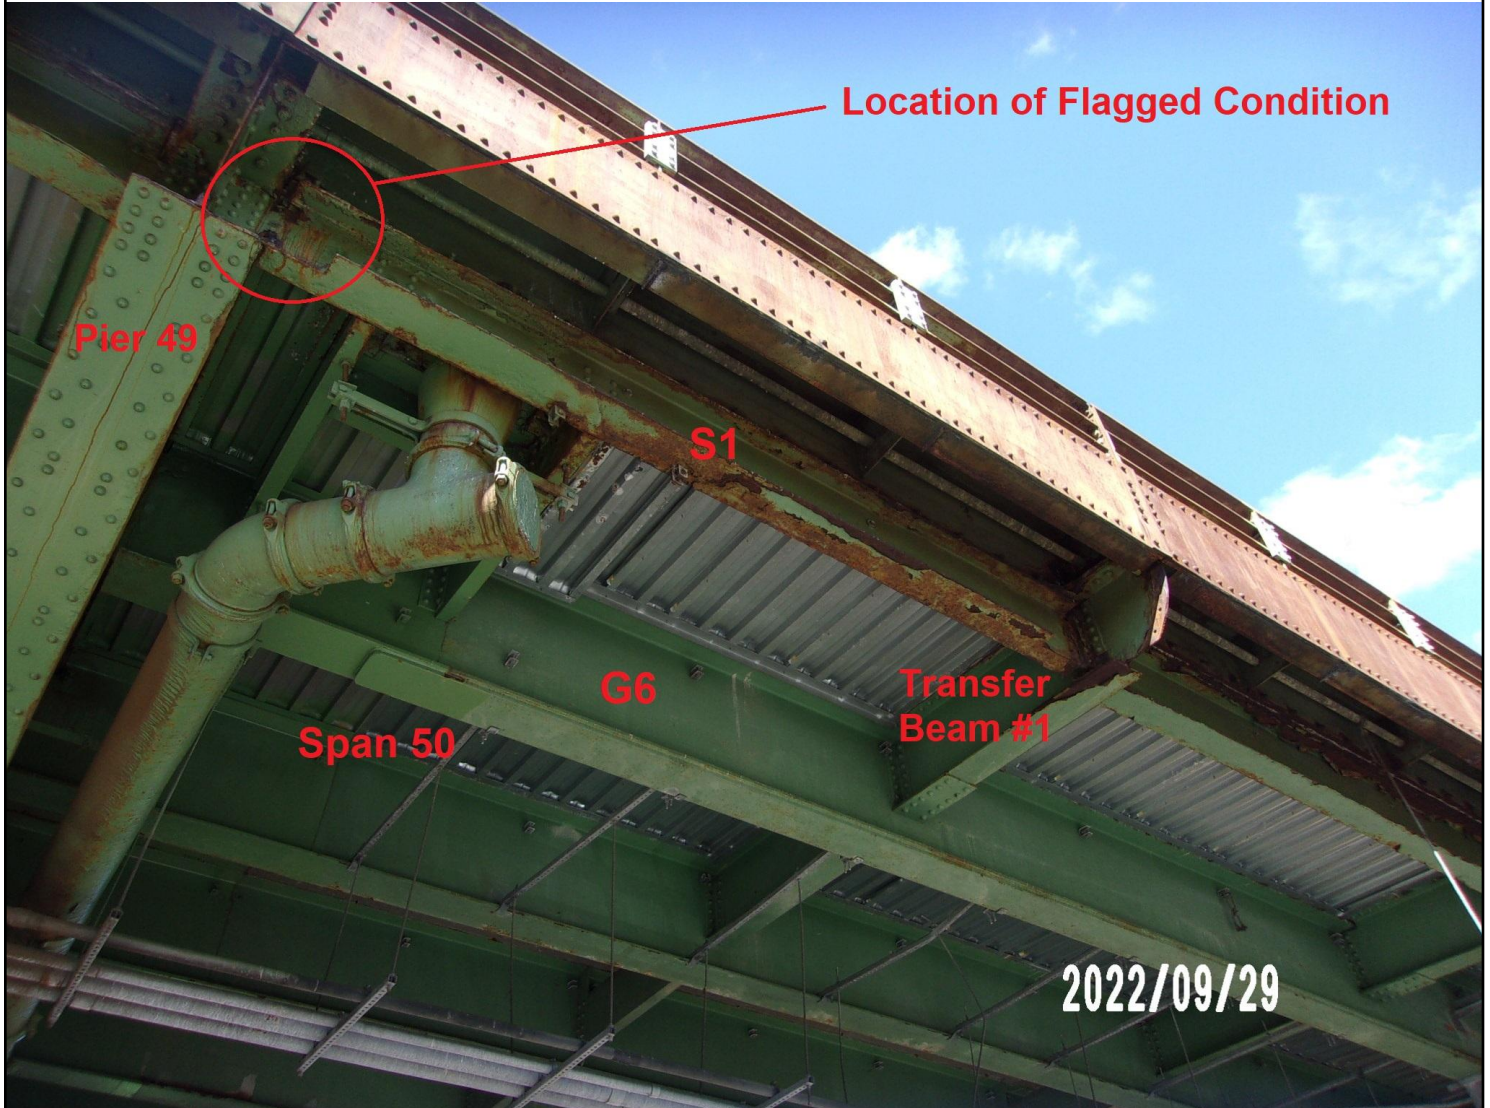
Photo Number: 4

**Attachment Description:** General view of the flagged condition at Stringer S1 in Span 50 at Pier 49. Looking Left.

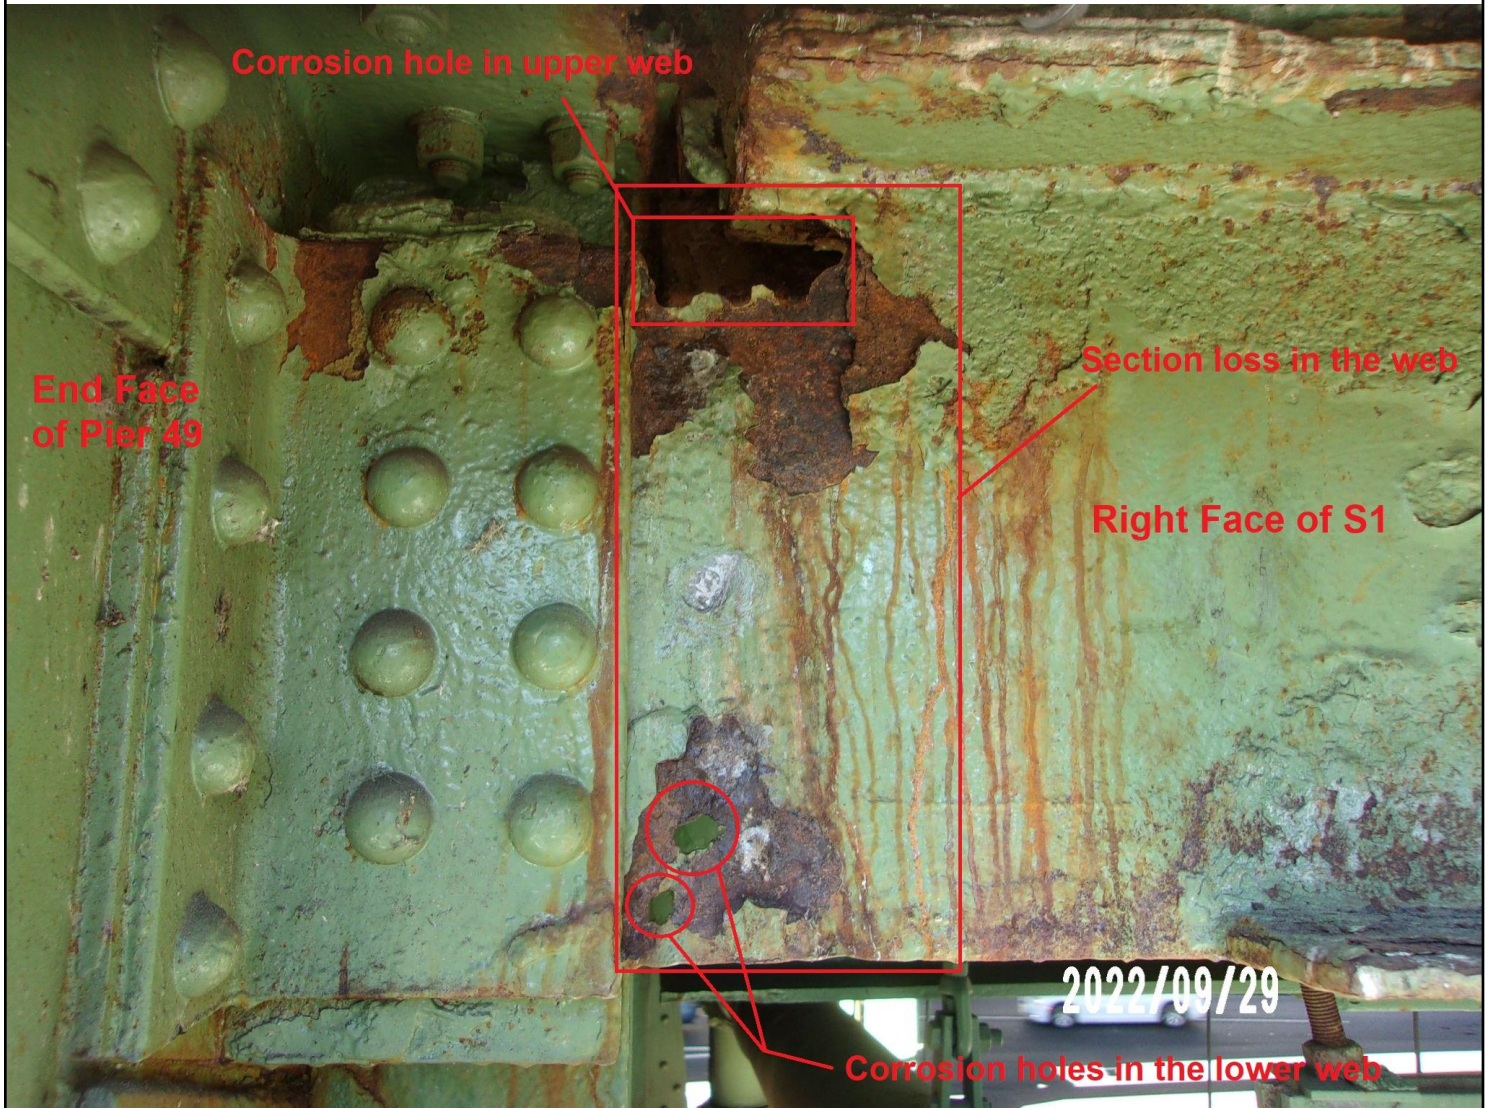
Photo Number: 5

The end of Stringer S1 in Span 50 at Pier 49 exhibits section loss for the full web height for 4" wide along the connection angles with remaining thickness measured (RTM) ranging from 0.13" to 0.29" resulting in approximately maximum 68% section loss (Photos 5 and 8). The upper stringer web at the top cope exhibits 4"L x 2"H corrosion hole (Photo 7). The lower stringer web adjacent to the connection angle exhibits two corrosion holes for 1/2" diameter and 1" diameter (Photo 6). The overall shear web area section loss is approximately 58% for this segmental stringer. (refer to Yellow Flag Condition Sketch Photo 2 for more details)

**Attachment Description:** The right face of Stringer S1 in Span 50 at Pier 49. The end of the stringer exhibits overall shear web area section loss of 58% for the full height of the web along the connection angle with one corrosion hole in the upper web and two corrosion holes in the lower web. Looking Left.

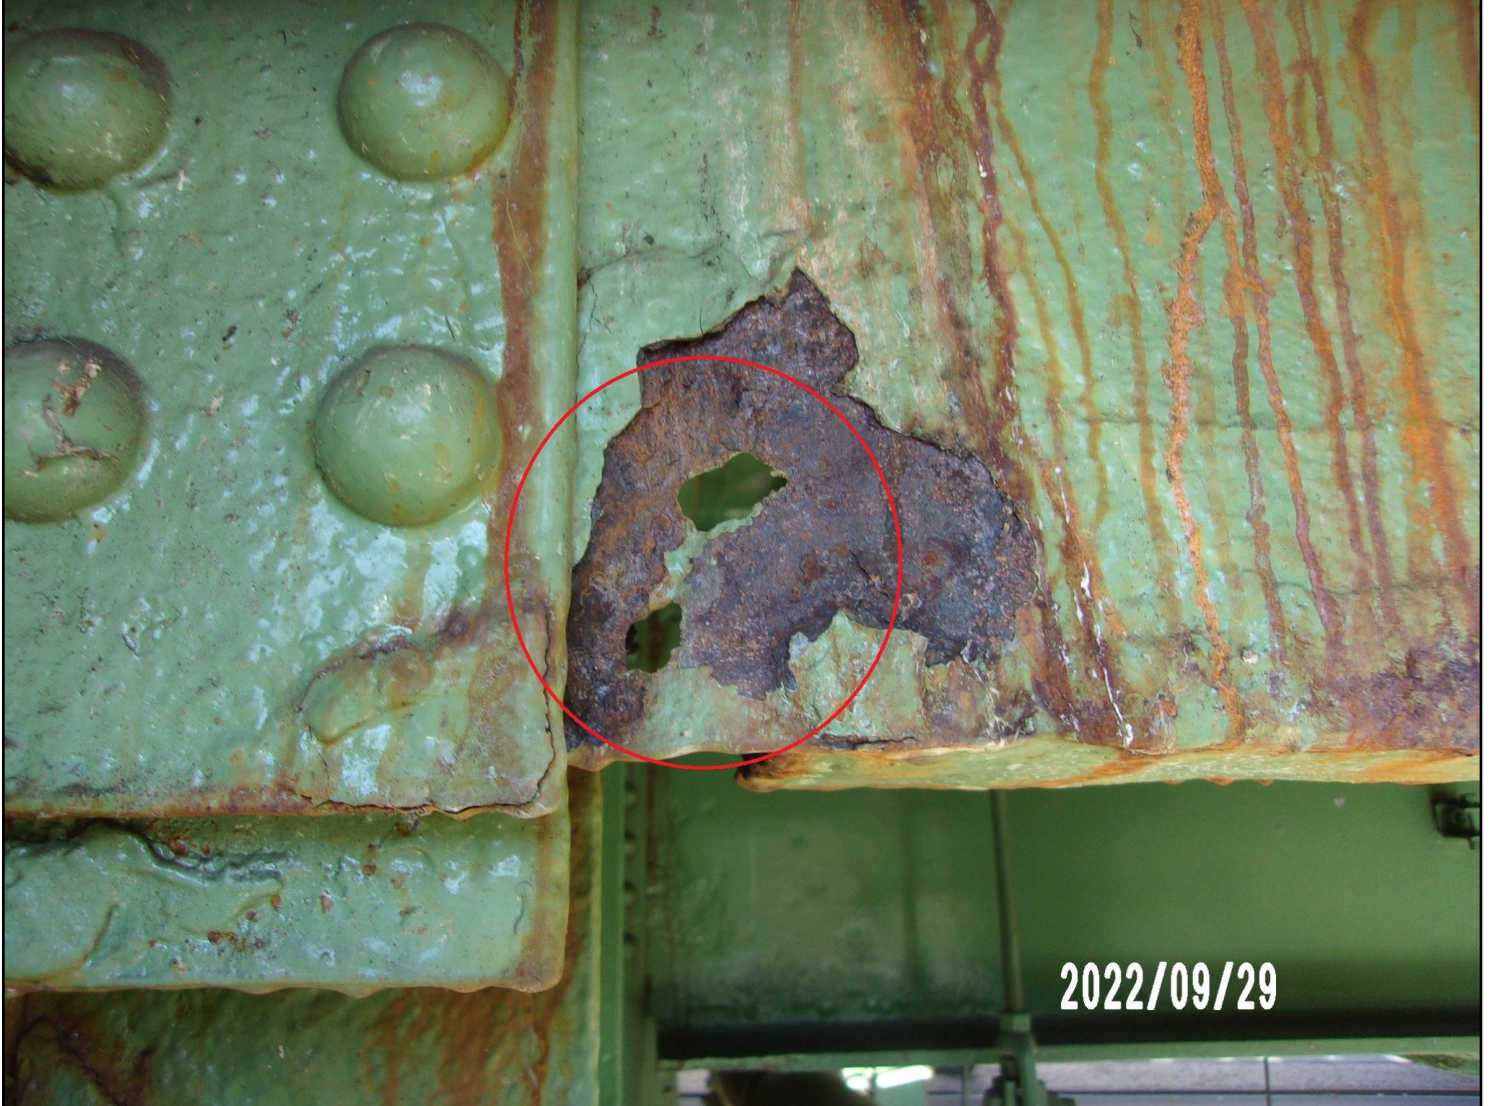
Photo Number: 6

**Attachment Description:** The right face of Stringer S1 in Span 50 at Pier 49. Close up view of the two corrosion holes for 1/2" diameter and 1" diameter in the lower web. Looking Left.

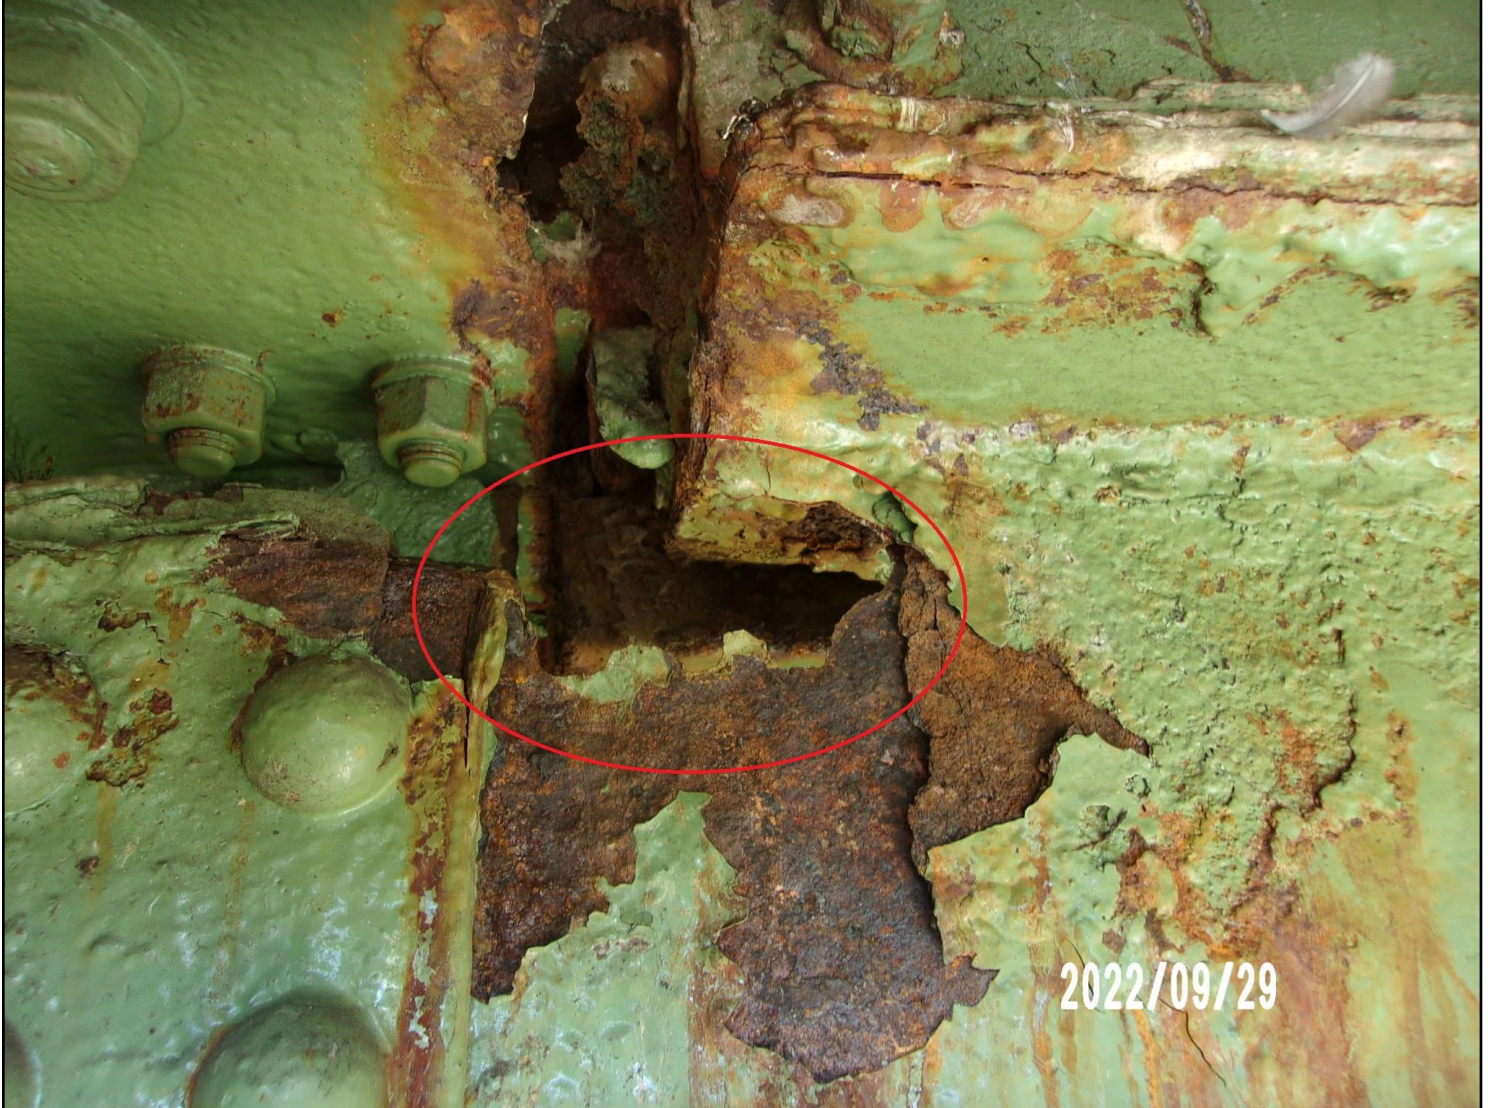
Photo Number: 7

**Attachment Description:** The right face of Stringer S1 in Span 50 at Pier 49. Close up view of the one corrosion hole for 4"L x 2"H in the upper web. Looking Left.

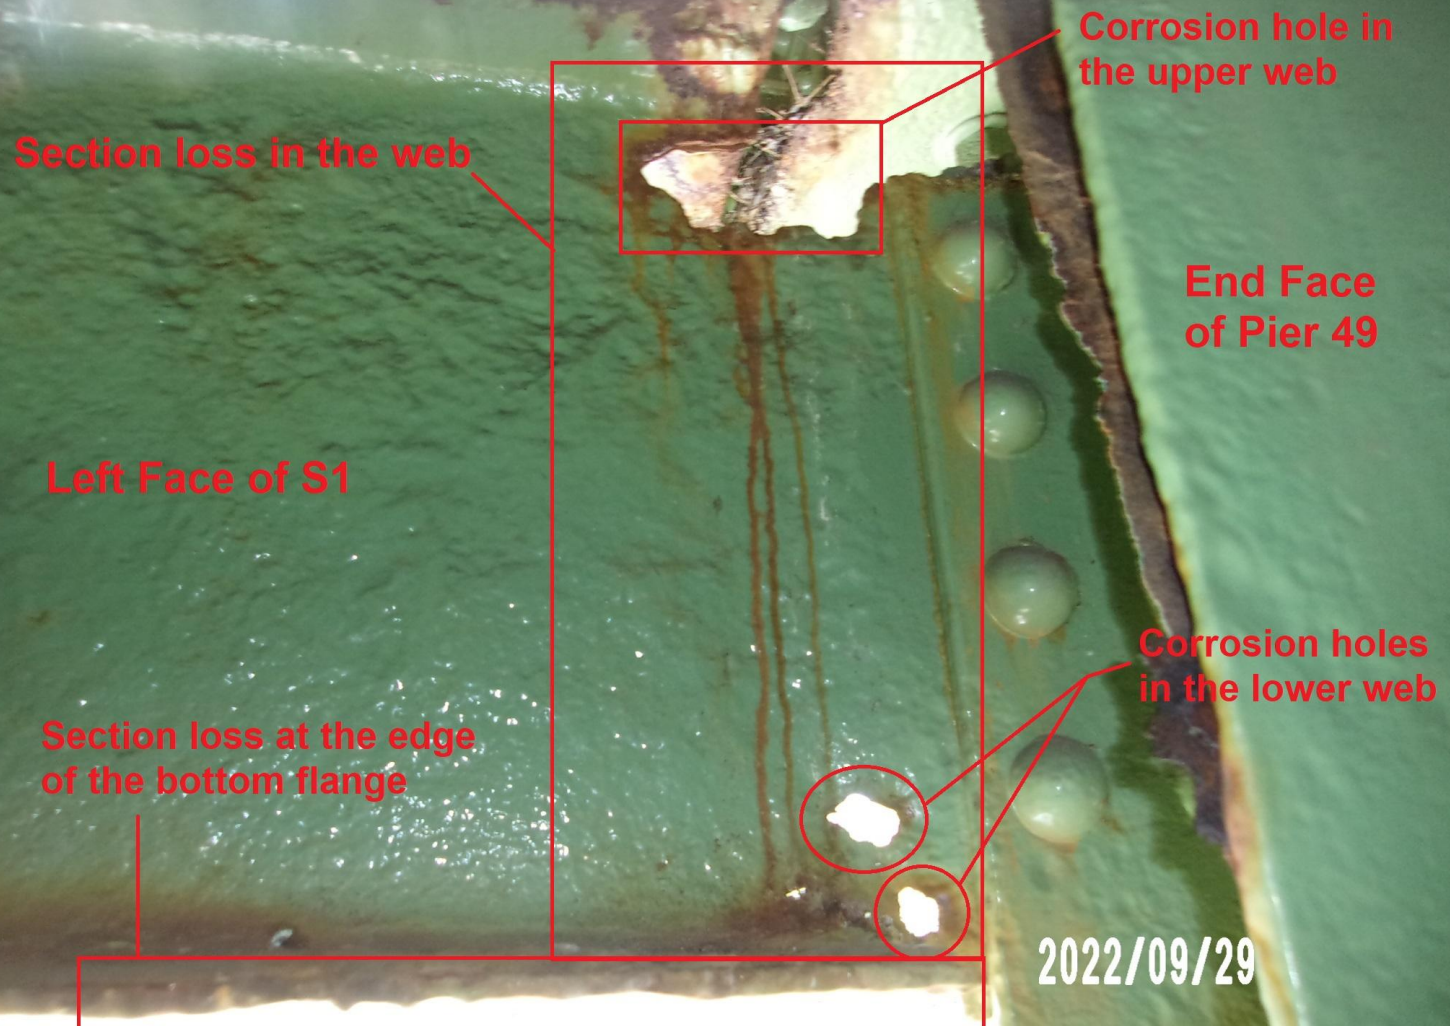
Additionally, the edge of the bottom flange exhibits 25% section loss to the left side for 18"L x 2"W (Photo 8). Also, both connection angles exhibit no significant defects.

**Attachment Description:** The left face of Stringer S1 in Span 50 at Pier 49. The end of the stringer exhibits overall shear web area section loss of 58% for the full height of the web along the connection angle with one corrosion hole in the upper web and two corrosion holes in the lower web. Also, the edge of the bottom flange exhibits 25% section loss. Looking Right.

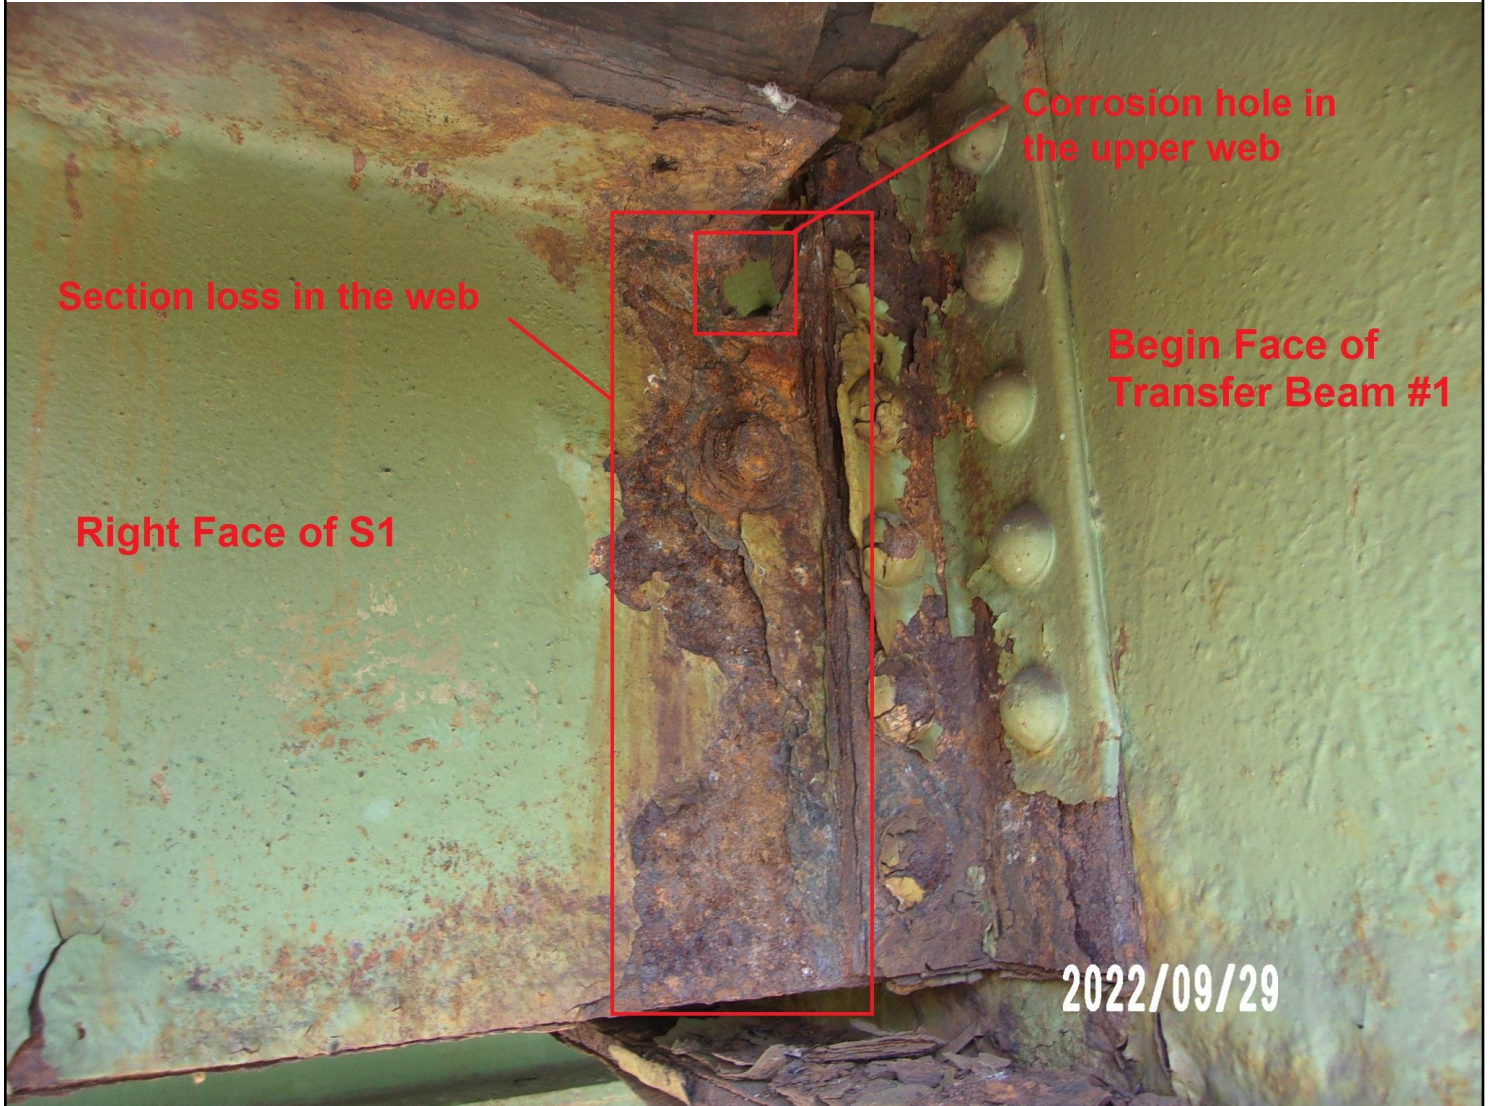
Photo Number: 9

This portion of Stringer S1 is approximately 16ft long from Pier 49 to Transfer Beam #1 (TB1). Stringer S1 at the connection to TB1 exhibits section loss for the full web height for 3" wide along the connection angles for up to 1/16" deep at the left face and 1/8" deep at the right face with 2" diameter corrosion hole in the upper web at the top cope (Photo 9). Both connection angles at TB1 exhibit no significant defects.

**Attachment Description:** The right face of Stringer S1 in Span 50 at Transfer Beam #1. The end of the stringer exhibits 1/8" section loss for the full web height along the connection angle with one corrosion hole in the upper web. Looking Left.

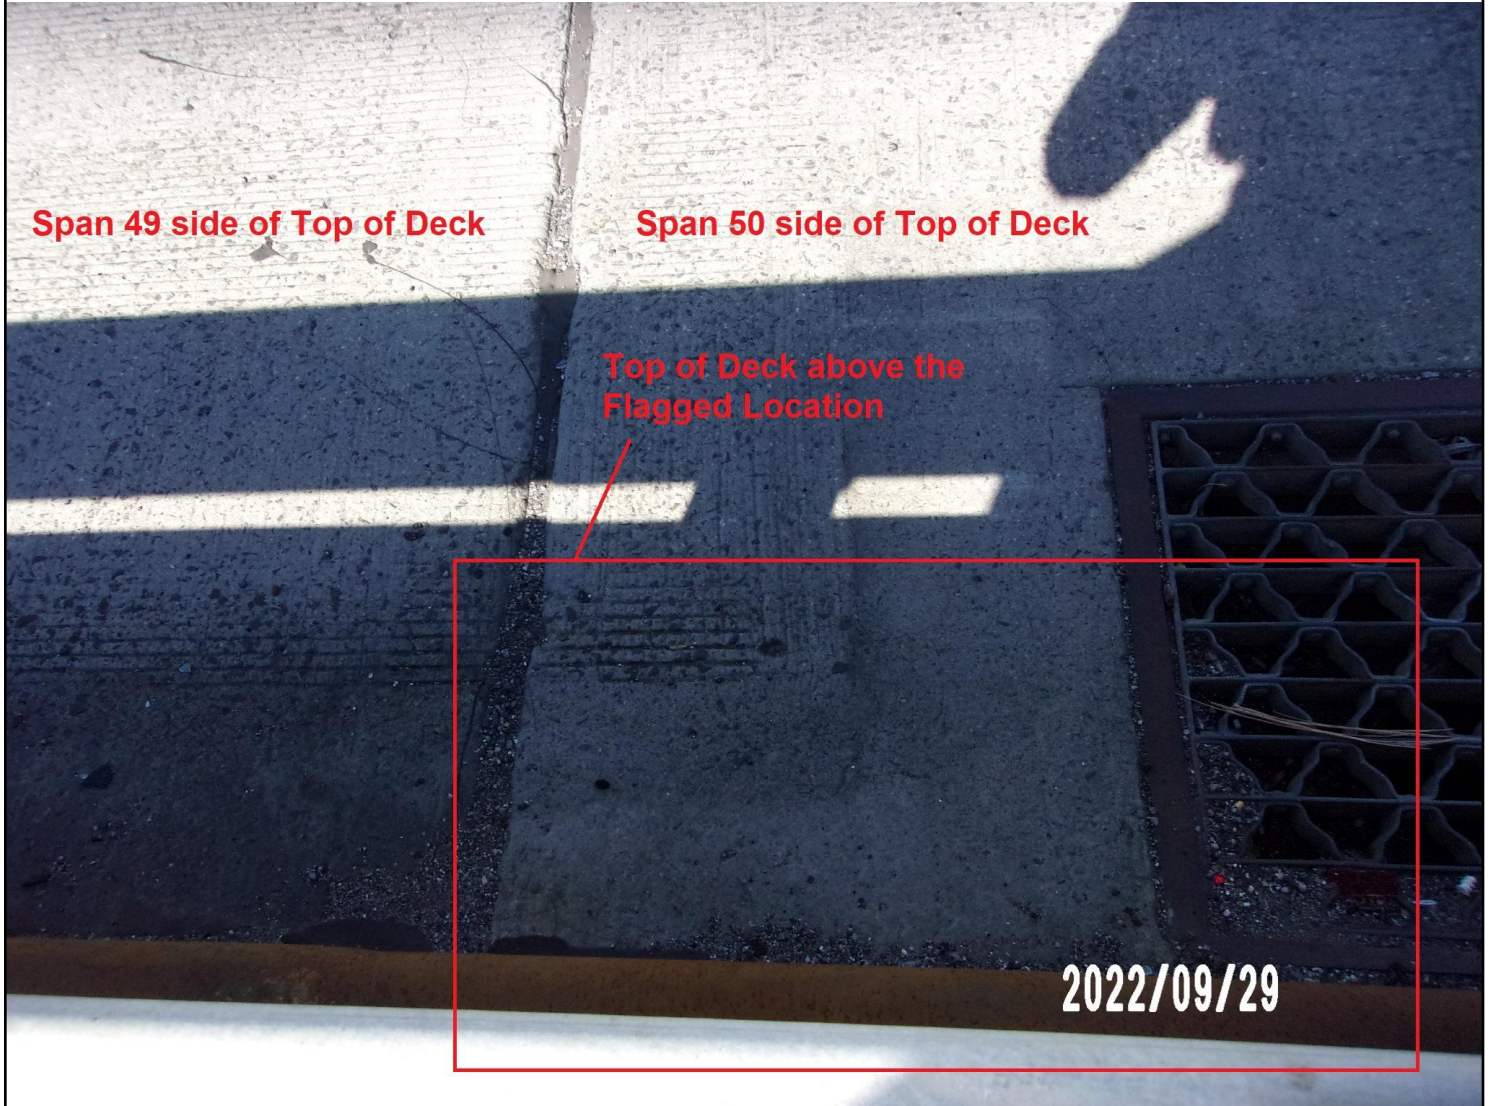
Photo Number: 10

**Attachment Description:** The top of the deck above Stringer S1 in Span 50 at Pier 49. The top of the deck above the flagged condition exhibits no significant defects. Looking Left.
